Borthwicks area

PORTLAND  
Sheet 1 of 5  
WRD 11/83 NTS

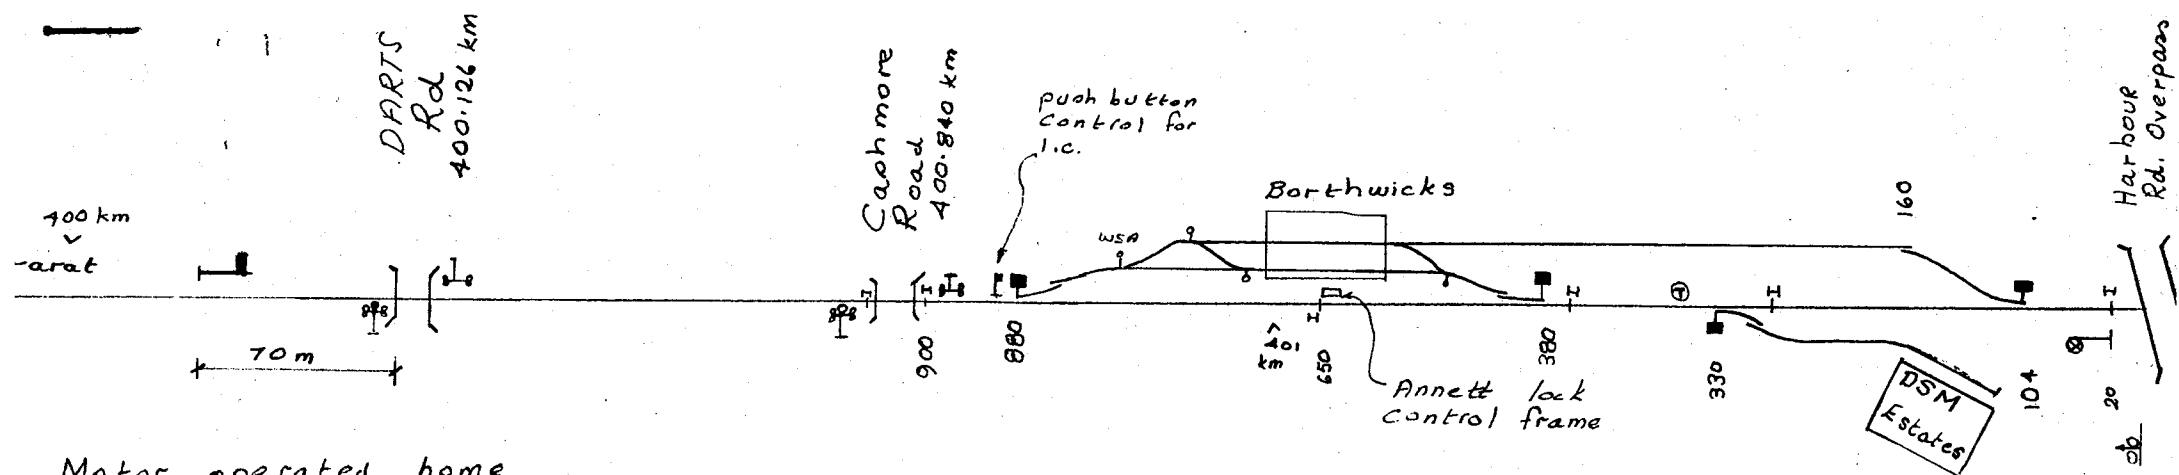
Motor operated, home signal, pole line started adjacent to this signal.

At Borthwicks, the Cashmore Rd level crossing, can be push button operated.

Noted 27/9/81, that the down end Borthwick turnout (at 104) had the K crossing removed, & the line was disused. By 1/83, line, & turnout relaid in 94 1/2 kg rail, except for catch point, & line rebalasted.

Point levers, quadrant type, all with rodded catch points. The colour light signal, just up from the Harbour Road overpass, been there for some time, but not noted operational. - Covered over 9/81. Renewed cover 1983.

Pole line (1/83), intact to Cashmore Rd l/c, then cable laid on ground, to Annett lock Control frame.

All Turnouts on main line - Annett locked.

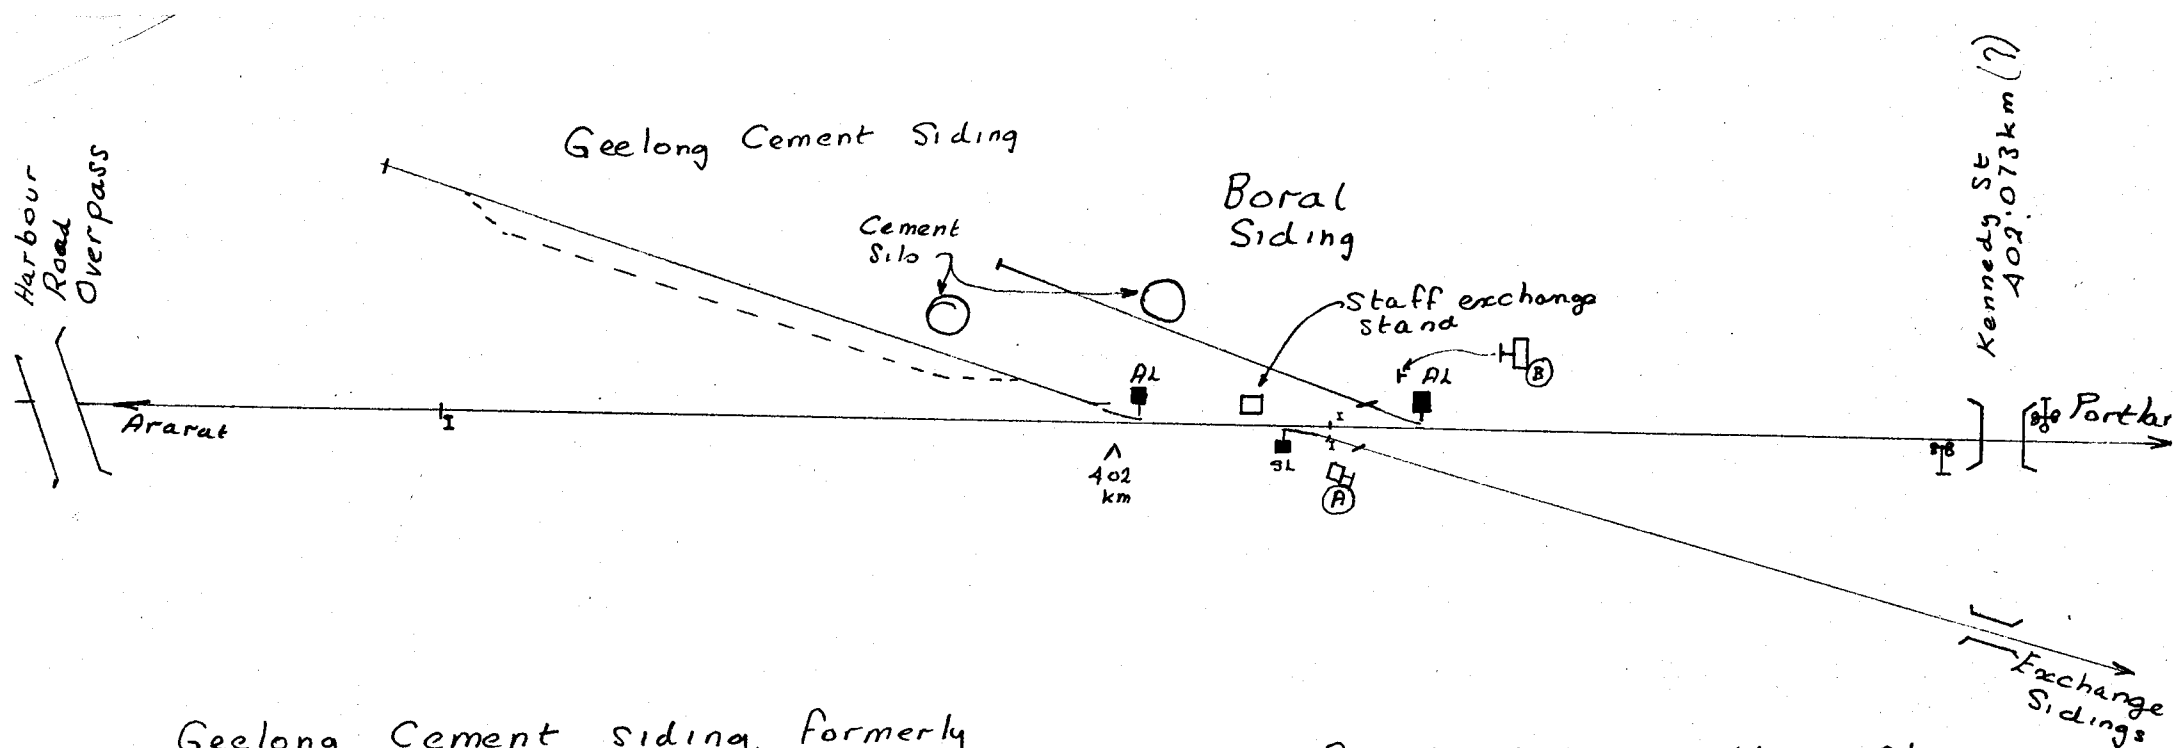
Sheet 2 of 5

Geelong Cement siding, formerly Portland Wool Stores, loop lifted by 9/81. Catch Point rodded to derail.

Port of Portland Authority (formerly Portland Harbour Trust) line, staff locked points, with electrical position detector + rodded derail.

Boral sdg, installed 9/81 Initially fitted with two derail blocks ~~was~~, both padlocked + points secured with a padlocked locking bar. By mid 82, fitted with Annett lock + rodded derail.

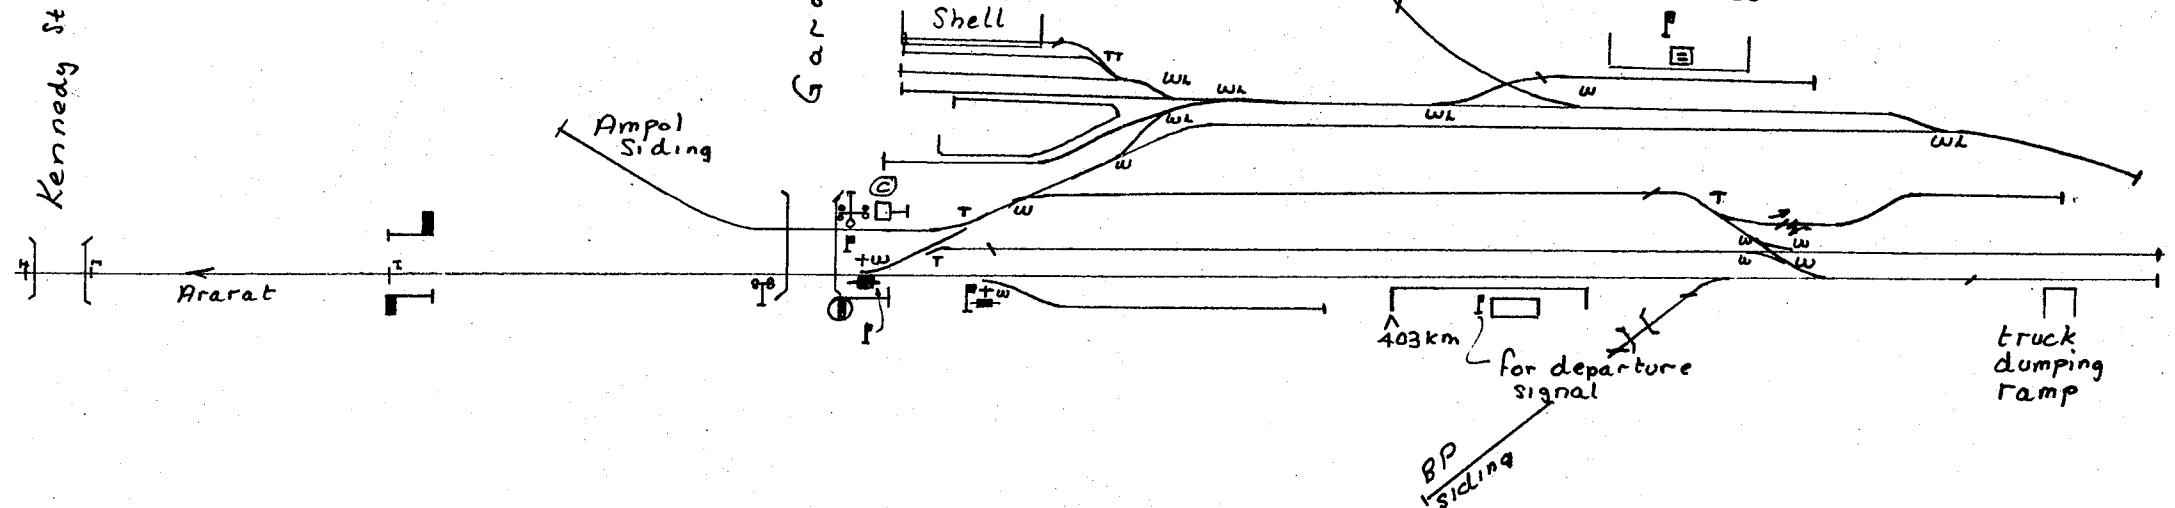
PORTLAND  
Sheet 3 of 5

Turnouts for No. 2 Road + dock road, fitted with WSA levers, detectors (wire + electrical), quadrant levers, plunger locks, + flashing light controls.  
No 1 Road bonded, signal levers for home arrival and departure on platform, - 1 fitted with Annett key. Telephone type box, controls push button for outer home, fitted with LED indicators, + signal indicator "On, Wrong, OFF", + Down Approach indicator + bell.

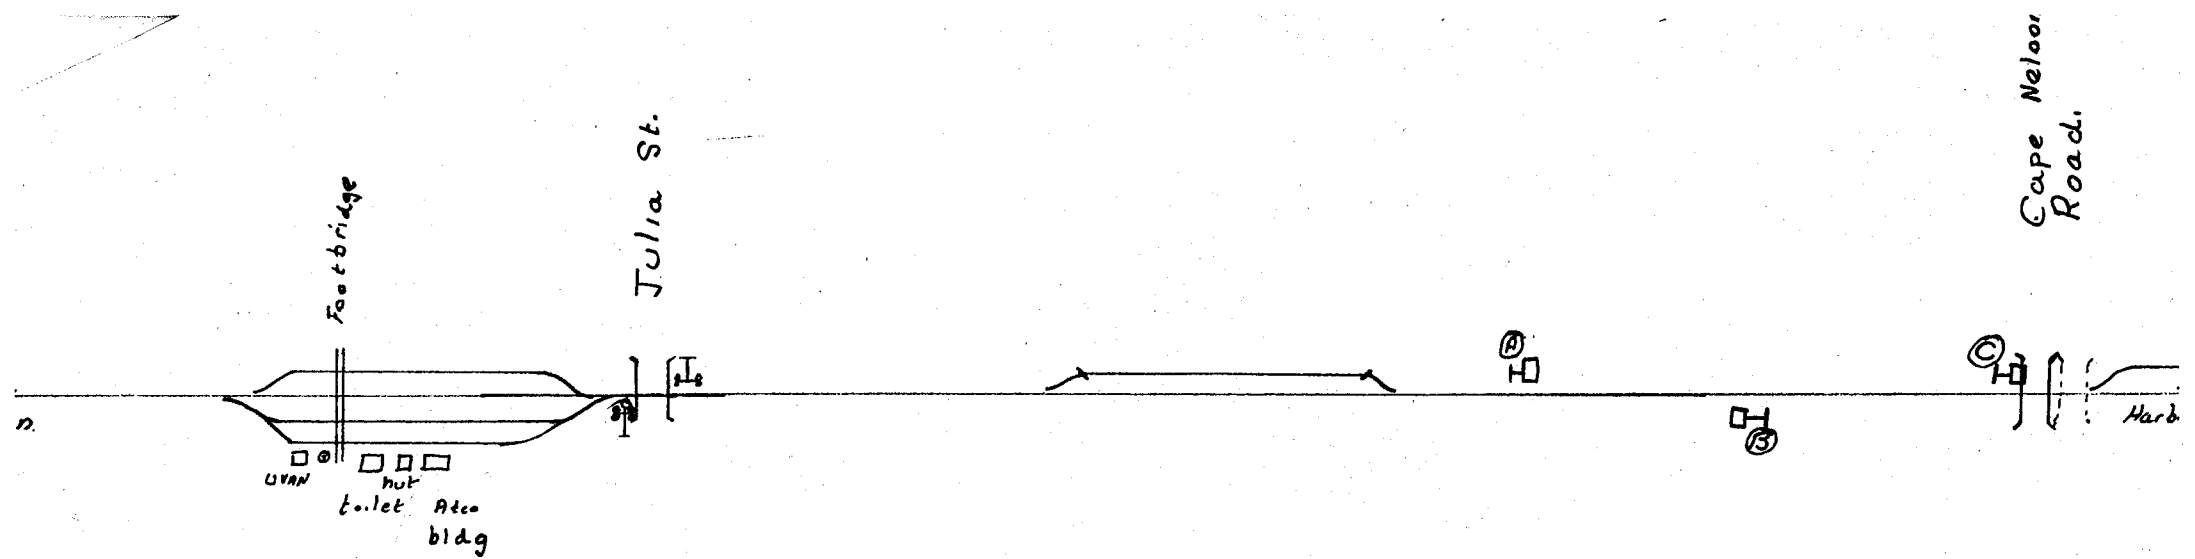
Sheet 4 of 5

WSA levers, with locking bars, on thru road (A only)

Julia St F.L.'s approach operated, has had notice boards, but vandalised.

WSA levers, with locking bars, siding has capacity for  $\approx 80$  GN's.

Installed during late 1981. In use for 81/82 wheat season. Used to inspect trains, prior to departure.

Air testing facility being installed 11/83.

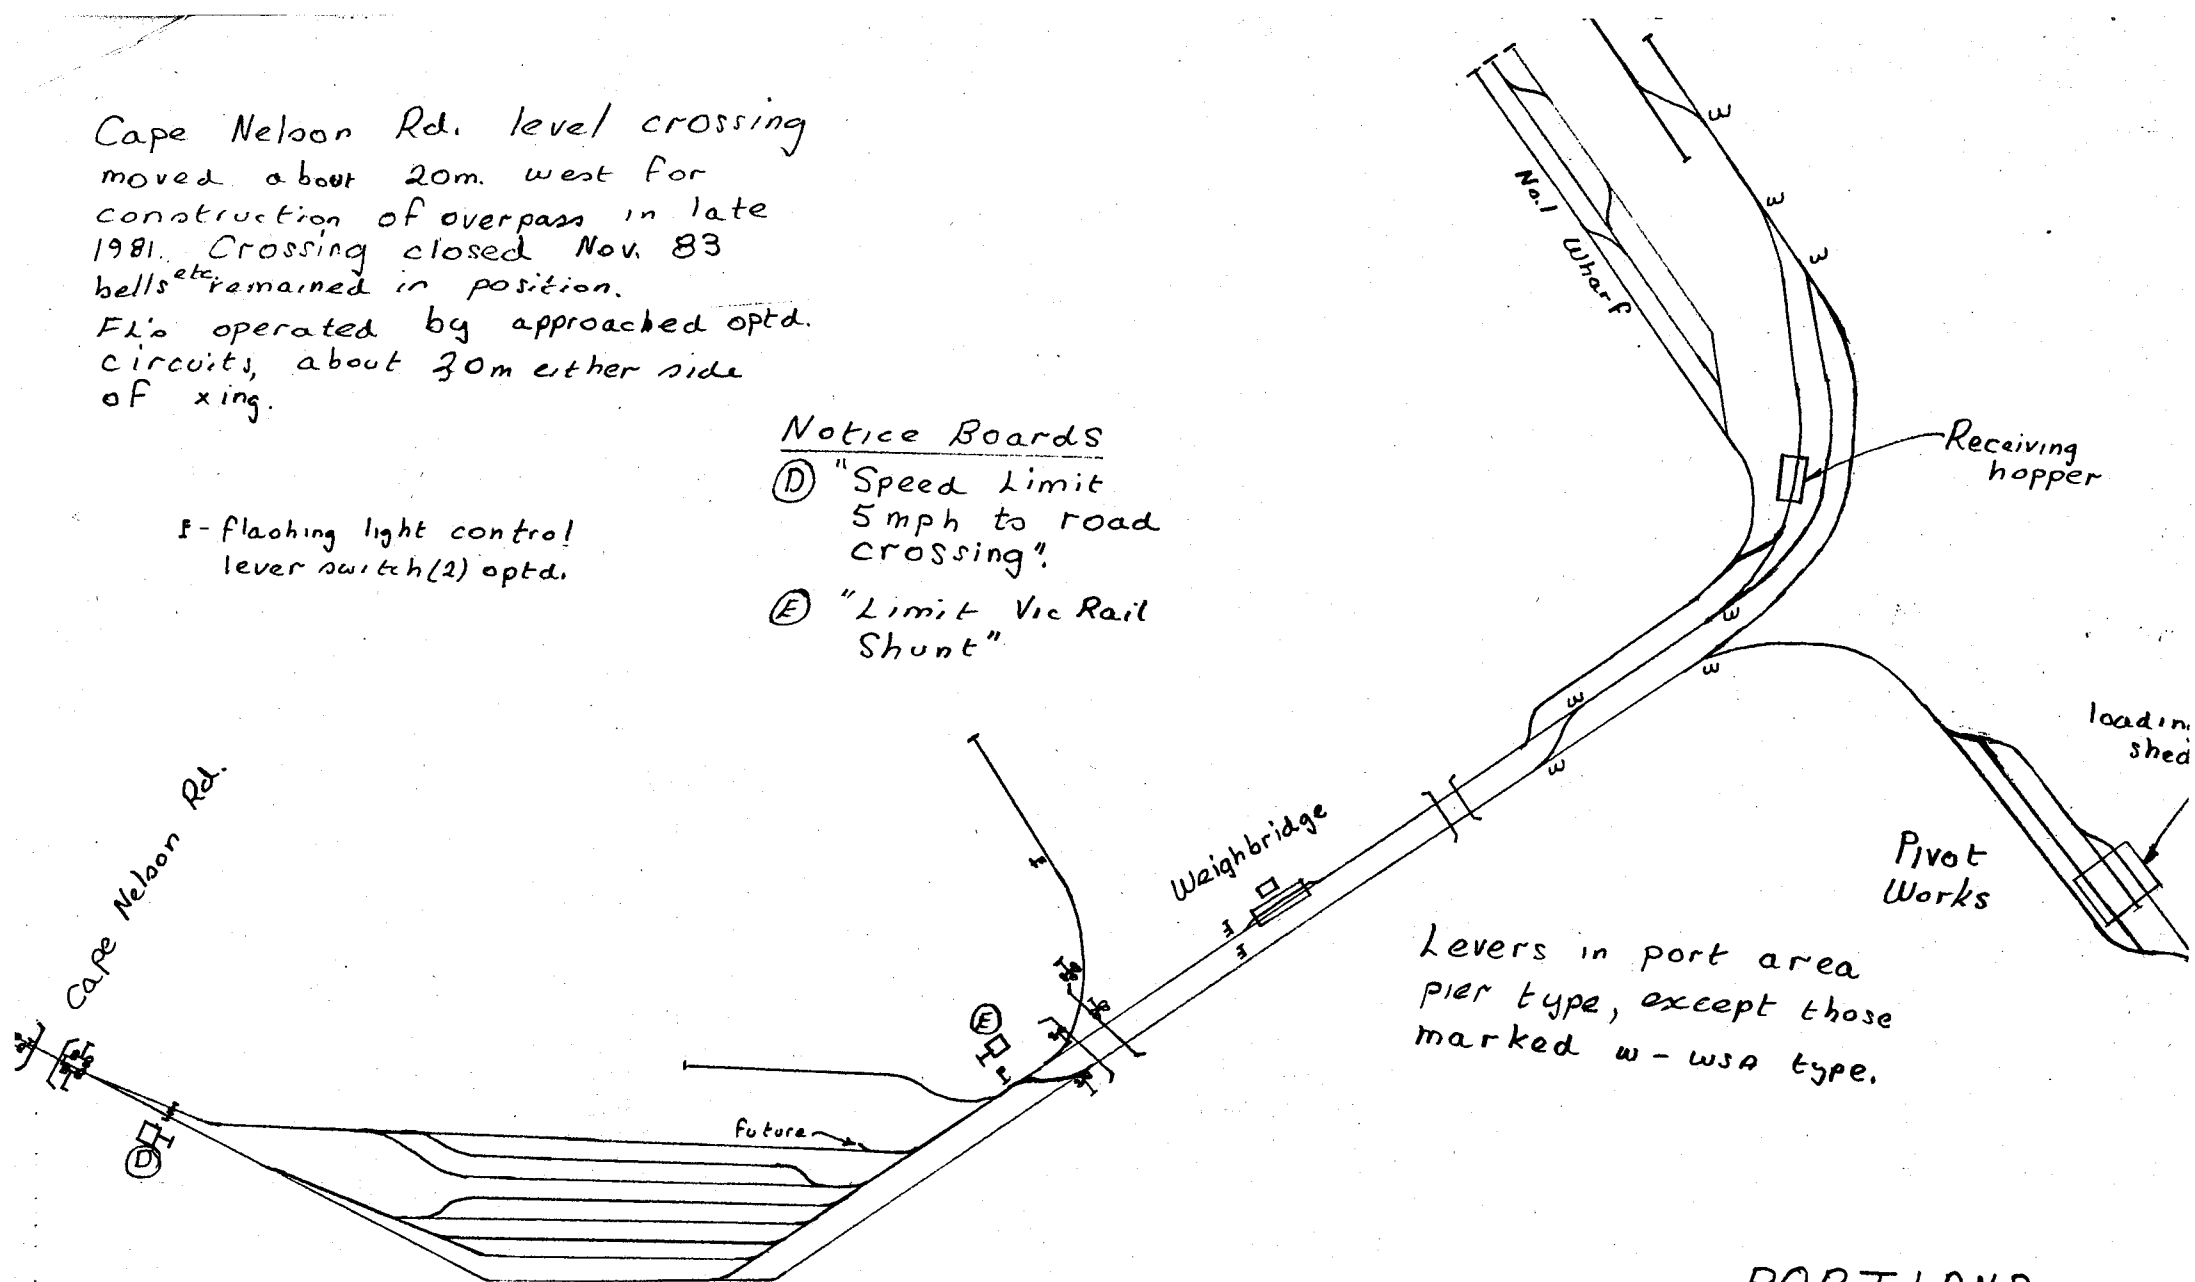
Sheet 5 of 5

Cape Nelson Rd. level crossing  
 moved about 20m. west for  
 construction of overpass in late  
 1981. Crossing closed Nov. 83  
 bells<sup>etc</sup> remained in position.  
 FL's operated by approached optd.  
 circuits, about 30m either side  
 of xing.

All WSA levers
