Borthwicks area

PORTLAND  
Sheet 1 of 5  
WRD 11/83 NTS

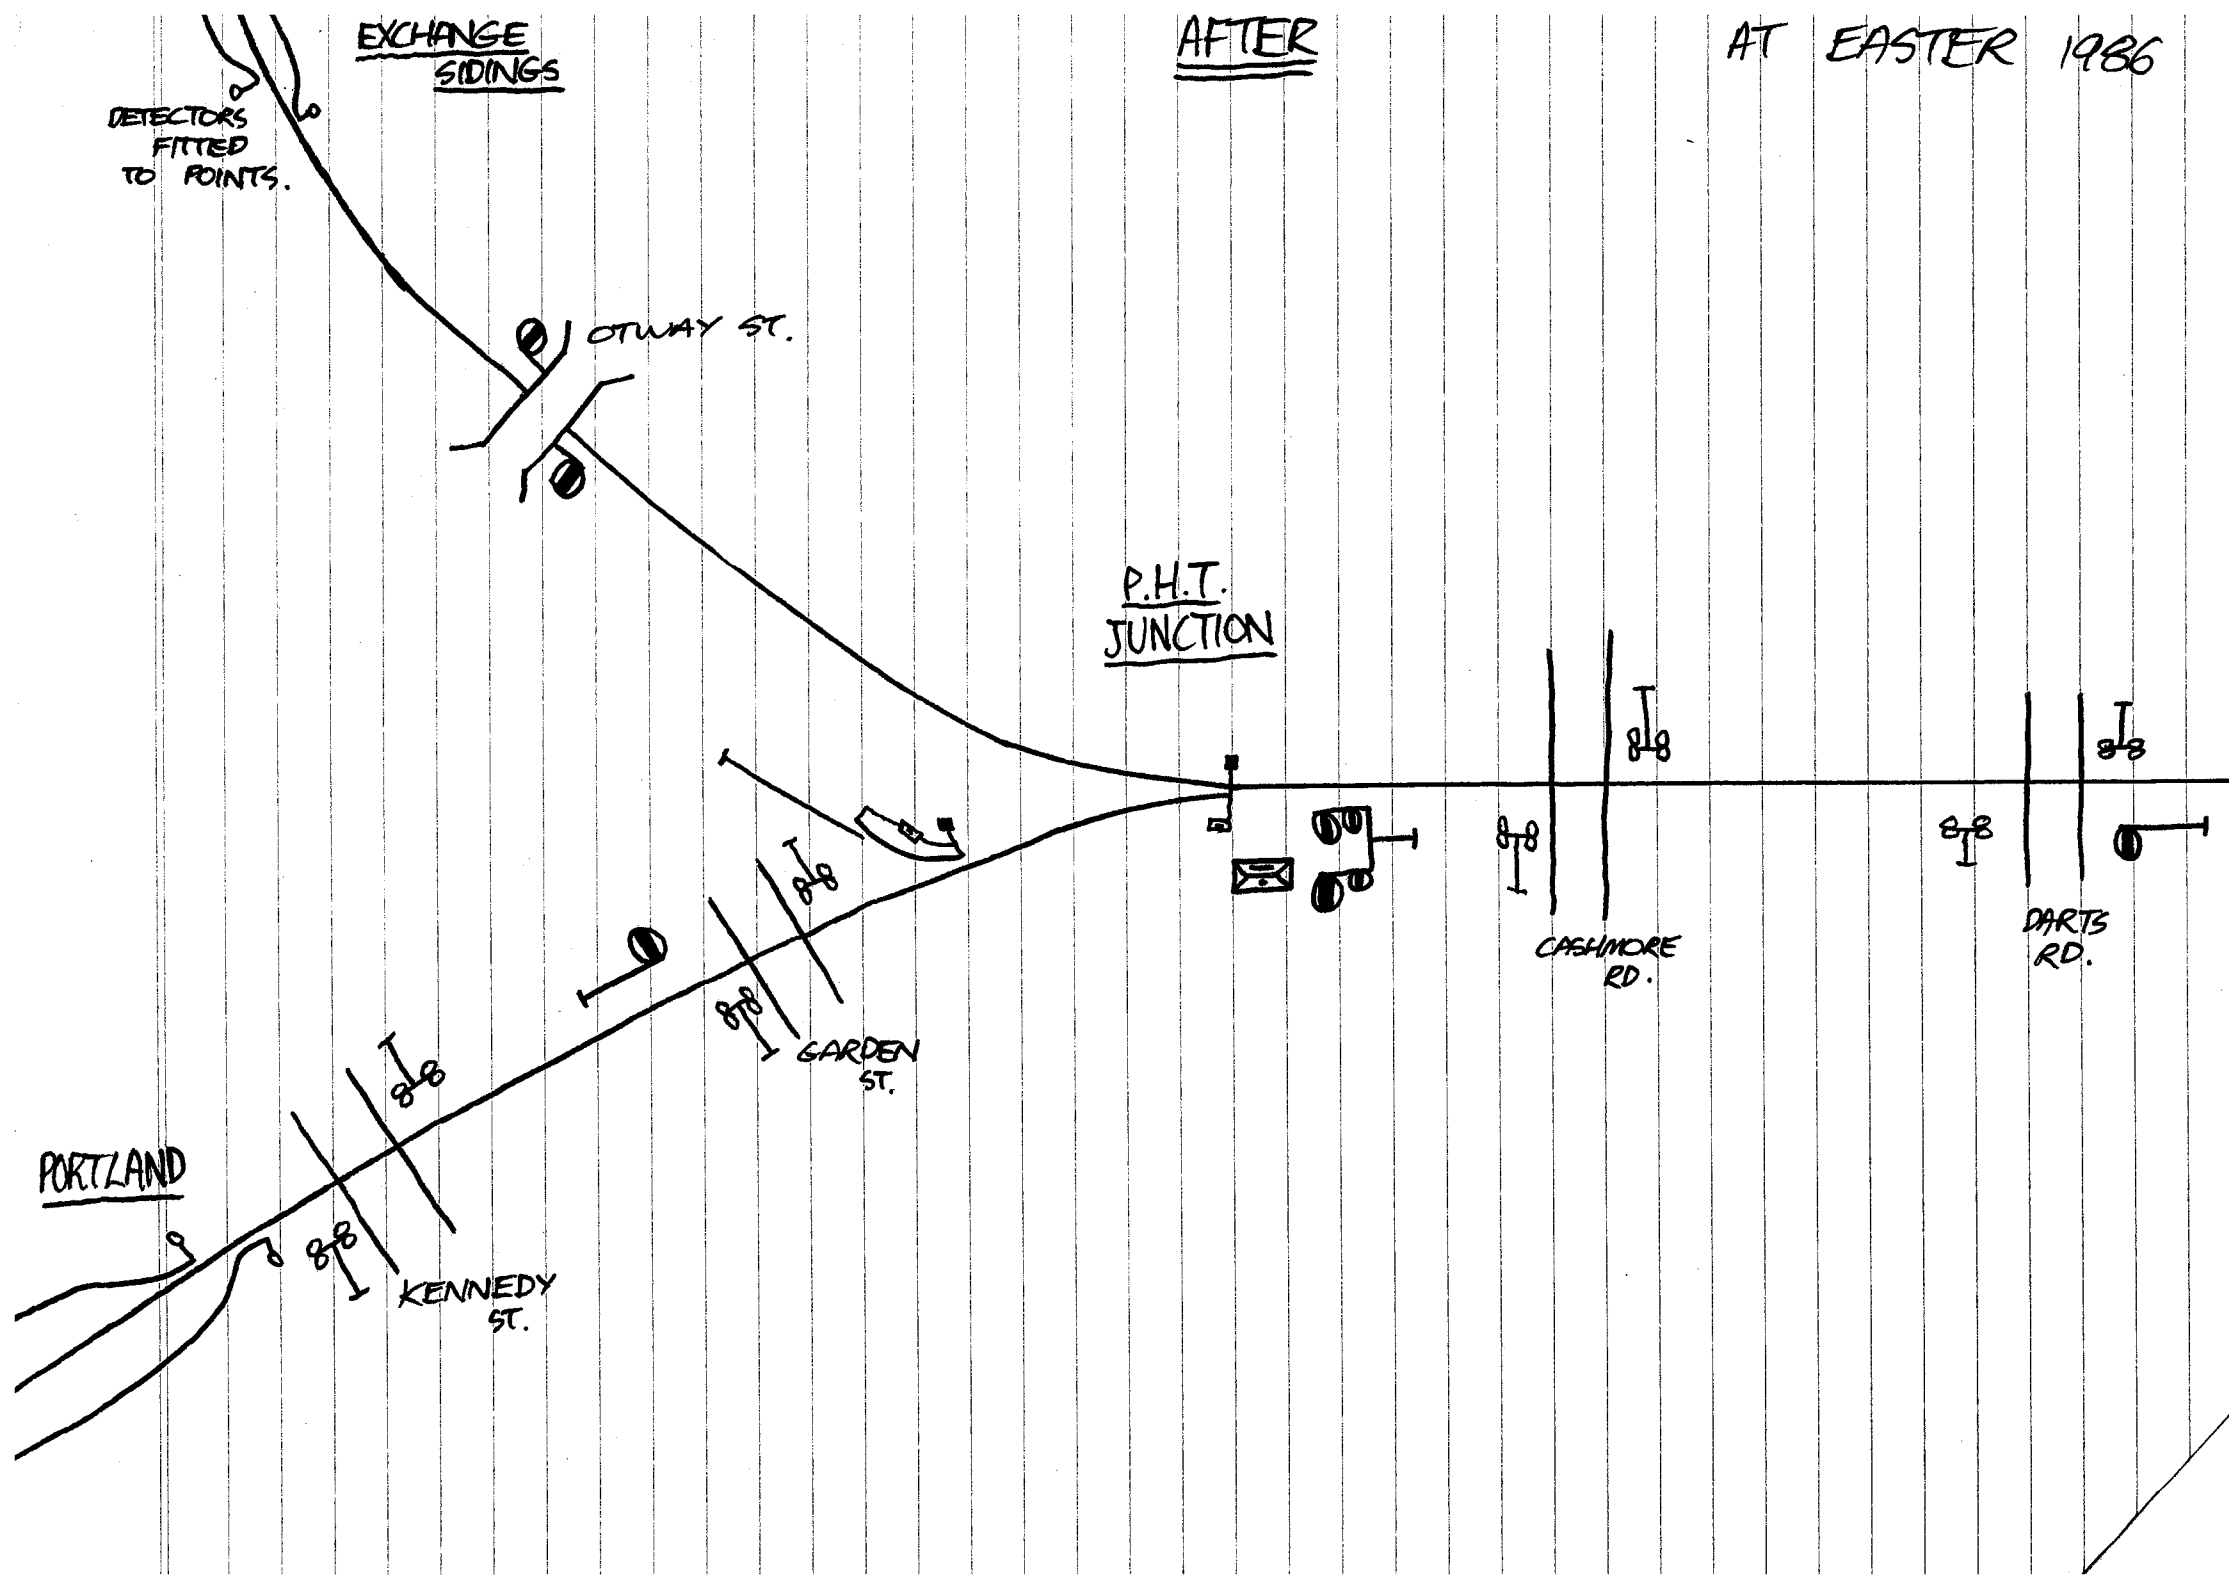
AT EASTER 1986

DETECTORS  
FITTED  
TO POINTS.
